## **Definition, Classification and Inspection Methods of Cracks in Photovoltaic Cell -- Cracks Induced by Vibration Caused by Transportation**

This paper discusses cracks in photovoltaic cell caused by en-route transportation to customer, often discovered by observing power efficiency reduction in final photovoltaic cell and module products, or outright disruption of electrical generation for that particular solar cell. The vibration by different transportation modes might induce crack propagation. Crack propagation of inner micro-cracks might lead to larger cracks in the millimeter or larger scale. These larger cracks affect the solar cell product quality. How to define these cracks and classify them pertaining to which ones might be contributing to potential power efficiency reduction is very important for the ability to define higher quality and yield photovoltaic cell products. Furthermore, crack observation and inspection methods in the manufacturing lines, field implementation, and during en-route transportation to customer site, and crack observation after installation were discussed and addressed. Cell vibration test methods will be addressed in a separate paper.

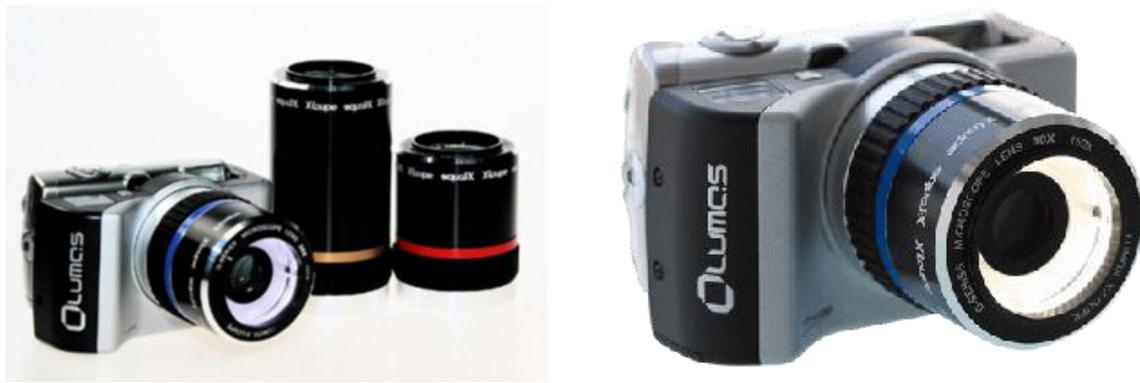
Figure 8 Portable Digital Microscope for Detecting Cracks and Micro-cracks.

To resolve this problem, we introduce the portable digital microscope (Figure 8), which is one type of optical microscope. The main feature is that it provides mobility while also with good magnification (300X). At this magnification, portable digital microscope has the ability of telling the difference between scratch and crack, also meeting our requirement to detect micro-cracks below 30-50 $\mu\text{m}$  with good mobility. Actually, the minimum-size crack on photovoltaic cells we can see is down to  $\sim 1.5\mu\text{m}$  in width. These micro-cracks are very likely to be the factor leading to cell breakage, especially when micro-cracks can propagate into larger cracks under stress. In addition, we can easily apply many light sources (UV light, Infrared light, and visible light) on portable digital microscope units.

As a result, portable digital microscope does prove that it can acquire high magnification microscopic pictures with its mobility. It can also serve as a consistent and

convenient crack observation and inspection tool set throughout wafer, cell, and module production lines - for the manufacturing lines, field implementation, and during en-route transportation to customer site, and crack observation after installation. This is a good tool to assist the existing EL and PL methods used in current photovoltaic cell factories.
